DOT/FAA/AR-95/51

Nondestructive Inspection of Piper PA-25 Forward Spar Fuselage Attachment Fitting

September 1995

Final Report

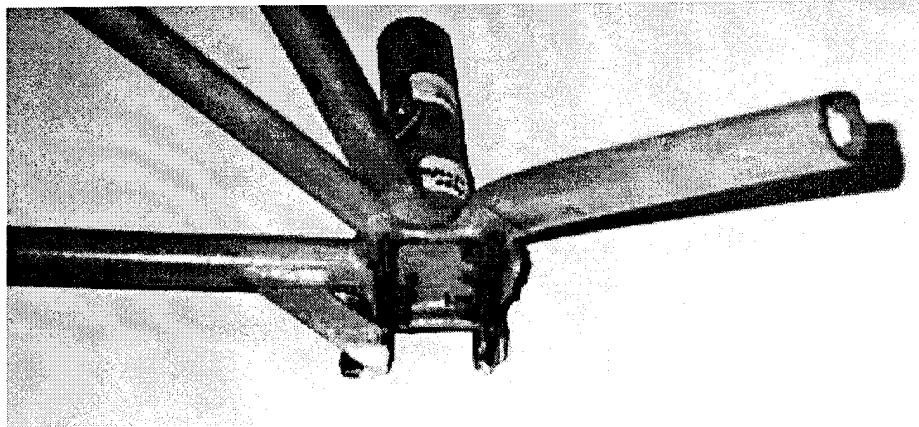
On May 21, 1993, an in-flight separation of the wing from a Piper PA-25 airplane occurred. The investigation of the affected airplane revealed corrosion and cracks in the forward spar fuselage attachment fittings. The forward spar fuselage attachment fitting consists of a clevis ear welded to a 4130 steel tube forward spar as illustrated in figures 1 and 2. This welded metal interface fractured at the base of the clevis ear. Extensive corrosion was found at the fracture site. Further review revealed that a strong oxidation layer between the two welded sections of the fitting assembly (washer and ear flange) had occurred over a long period of time. Figures 3 and 4 are photographs showing the corroded spar fuselage attachment. This airplane was used for agricultural crop dusting and had accumulated over 5,000 hours time in service (TIS) at the time of the accident. A similar accident had occurred previously on September 21, 1991, to an airplane with 10,000 hours TIS. These two different accidents alerted the FAA that an unsafe condition may exist on the Piper Model PA-25. The FAA also believes that airplanes utilized in agricultural environments are extremely susceptible to the above corrosion conditions.

FIGURE 3. PICTURE OF THE FORWARD SPAR FUSELAGE ATTACHMENT CLUSTER CUT FROM AN ACCIDENT AIRPLANE IN ALABAMA.

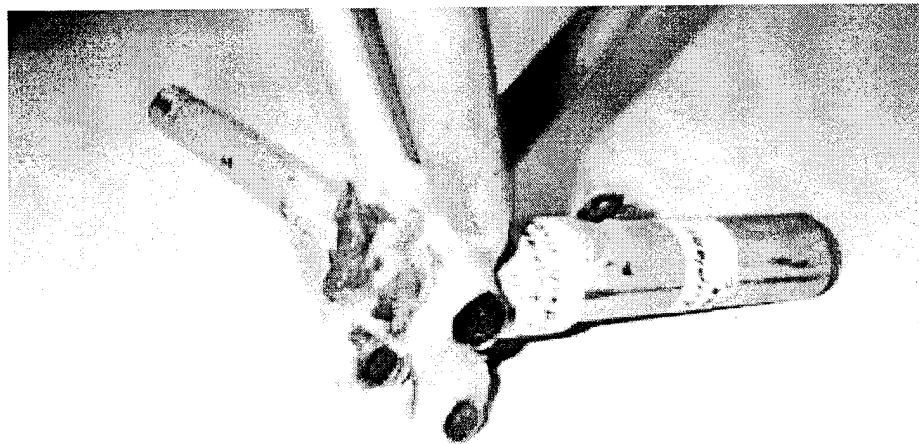
FIGURE 4. SIDE VIEW OF FIGURE 3 THAT DISPLAYS THE EXTENSIVE CORROSION OF THE FITTING EARS.

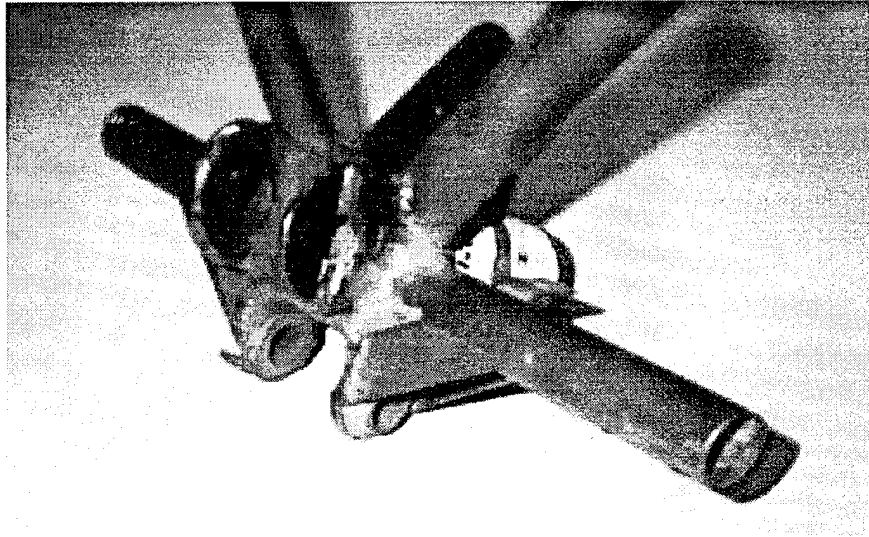
corrosion on both ear fittings. Half of one ear was removed by a bandsaw to reveal the inner layer corrosion shown in figure 6. Sample 3 was a forward spar fuselage attachment cluster used as a blind sample to develop the inspection techniques. It was not known if corrosion existed between the inner layers. Sample 3 is shown in figure 7. The AANC staff performed both radiography and ultrasonic inspections on the spar cluster assembly. Test setup, calibration, and inspection techniques are described, and findings from each technique are stated.

The gap between the washer and ear flange was measured to be between 0.015 to 0.025 inch for the corroded sample 2. The standard design tolerance for this gap, however, was unknown so an assessment of the corrosion thinning could not be made. Cracks in the inside tube diameter of sample 2 could not be detected. Alignment between the x-ray source and the spar cluster would be critical if this technique was used to find cracks in the tubing. For this application, radiography would not be reliable in finding cracks in the tubing without conducting several exposures at different orientations.

FIGURE 6. SAMPLE 2 - FORWARD SPAR FUSELAGE TUBULAR ATTACHMENT CLUSTER FROM A PA-25 AIRPLANE. NOTE: HALF OF ONE EAR WAS REMOVED BY A BAND SAW. THE DARKER AREA IS CORROSION.

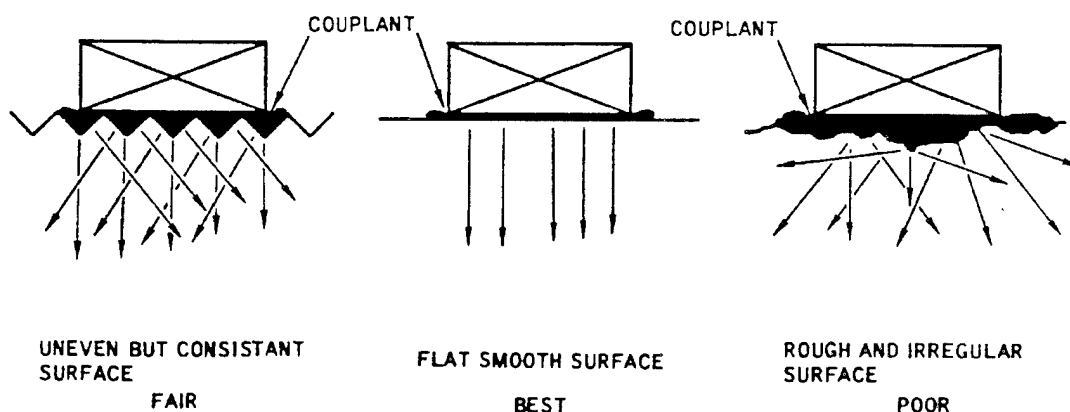
The test setup was then applied on the surface corroded sample 2. The thickness of sample 2 could not be determined. The instrument sensitivity (gain) was increased and the backwall echo still could not be detected. The problems with sample 2 were due to the rough outer surface of the test sample. Figure 11 illustrates the undesirable effect of surface roughness on the distortion of ultrasonic wave propagation. This probe and technique were abandoned.

FIGURE 11. ILLUSTRATION OF THE UNDESIRABLE EFFECT OF DISTORTION OF WAVE DIRECTIVITY DUE TO THE SURFACE OF THE TEST SPECIMEN AND HOW IT CAN GREATLY AFFECT ULTRASONIC WAVE PROPAGATION.
